THE UGHEDZOR LANDSLIDE DISTRICT (ARMENIA) AND A PROBLEM OF RUNNING OF THE STRATEGIC MOTORWAY

Boynagryan V.R.

Yerevan State University, Yerevan, Armenia
vboynagryan@ysu.am

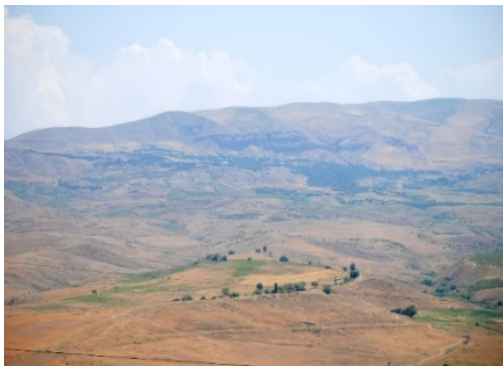
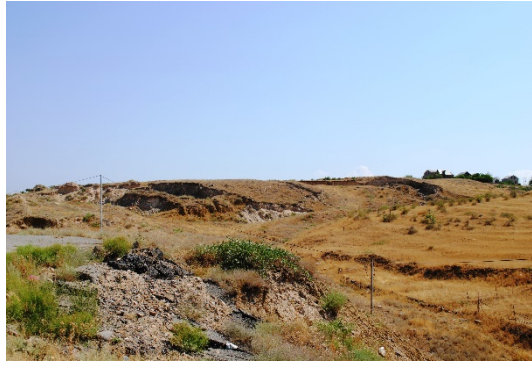
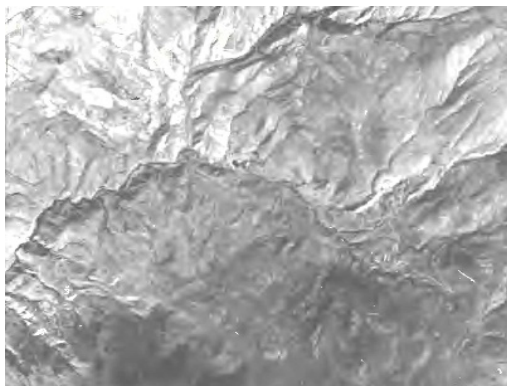
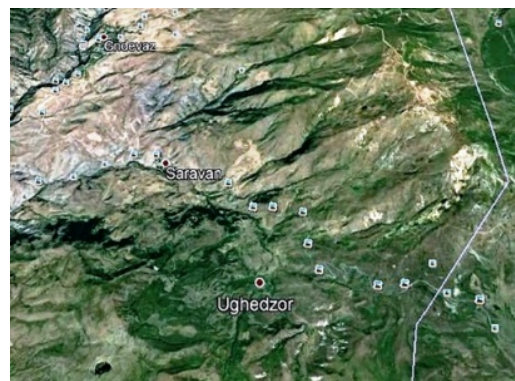
Fig. 2. Ughedzor landslide site: terrain photograph (a - b), aerial photograph (c), satellite image (d).

The landslide site includes both sides of the valley of the Darb River. Here, in the volcanogenic-sedimentary thickness, along the line of the active fault, to which the epicenter of the Vayots Dzor destructive earthquake of 735 (M=6.5-7.0) is confined, several large landslides-blocks and landslides-flows were formed, which are clearly recorded in the terrain (a), aerial (b) and satellite (c) images [2] (see Fig. 2).

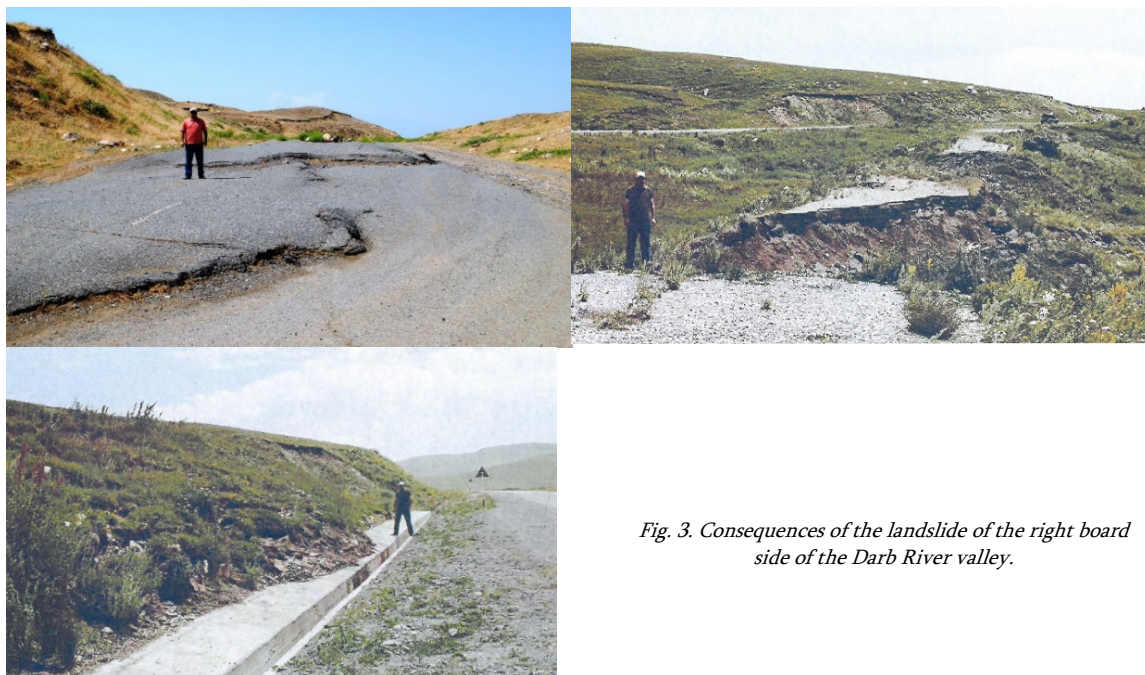
Fig. 3. Consequences of the landslide of the right board side of the Darb River valley.

The body of the landslide is heavily moistened by the waters of springs, as well as numerous ravines draining the slopes adjacent to the landslide and unloading their waters into the body of the landslide. Therefore, the surface parts of this landslide creep onto the roadbed of the strategic highway. The landslide itself is quite active, which is confirmed by the constant displacement of the roadbed down the slope and its destruction (see Fig. 3).

The large power of the landslide does not allow protecting the highway from destruction only by countering the displacement of the surface strata of the landslide mass. Interception of water with a concrete tray only a

temporary measure capable of stopping the creeping of these surface strata on the road. After all, the road is destroyed not from these surface masses, but from the displacement of the floodsliding with its entire mass.
