## THE CYCLE OF FLOODS AND THEIR NEGATIVE CONSEQUENCES IN THE KHARAGULI DISTRICT

**\*Gorgijanidze S., \*\*\*Kapanadze N., \*\*Jincharadze G., \*Pipia G., \*Kobakhidze N.,  
\*\*\*Chitadze T.**

*\*Institute of Hydrometeorology, Georgian Technical University,*

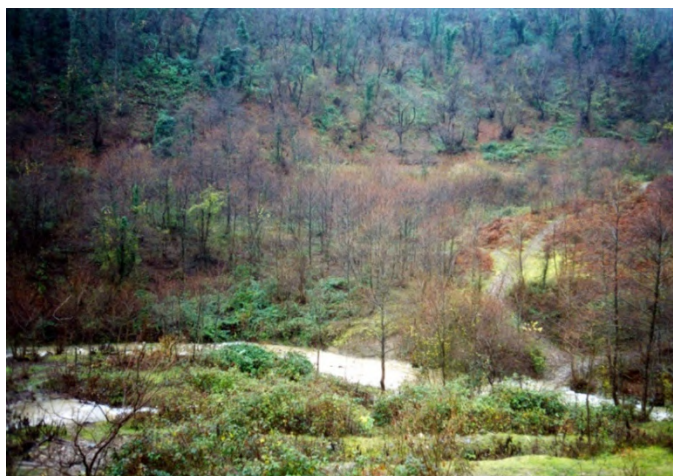
**Fig. 1.** Karneba River landslide, left slope (photo by S. Gorgijanidze 2001) [2].

Here we will highlight the Kharagauli district, where in 2001 a flood occurred on the Karneba River. The river washed away the entire erosion slopes and caused flooding in the lower reaches. With the help of expedition materials, which were conducted in December 2001 by Sofio Gorgijanidze and Vasil Tsomaia, as well as Tamila Kopadze, the river valley in the Kharagauli district was investigated. It was established that the entire river valley is landslide-prone, where creeping landslides also acquire a catastrophic character. (Fig. 2) Unfortunately, at that time, the damage and the area of flooding in the territory were not determined.

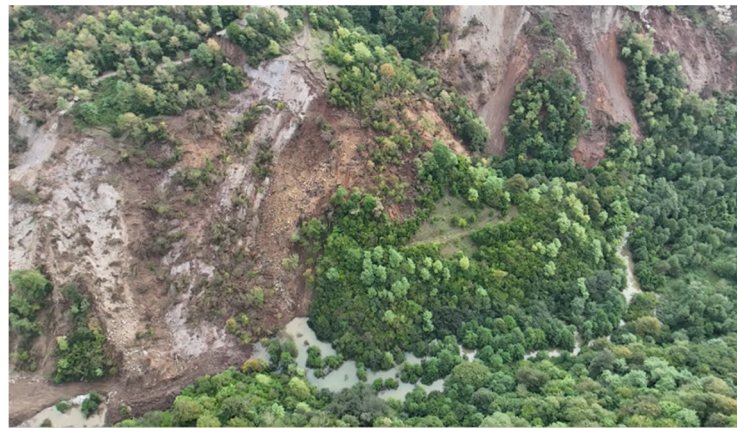
**Fig. 2.** The landslide and the dammed lake Karneba. (Photo by N. Kapanadze) 2025.

As for the events of 2025 in the villages of Khemaghali and Ghverki in the Kharagauli district, it is associated with the activation of landslide and rock avalanche bodies in terms of tectonics, which is still the subject of research. The process began around May and intensified gradually. This was followed by the blocking of the Karneba River at the end of August. The landslide that descended on the territory of the village of Lashe blocked the river and blocked it in several places. The landslide area is actually 72.5 ha. The largest blockage was the second-dammed lake, which posed a threat to both the village of Lashi and the central railway. (Fig. 2).

It should be noted that flooding was prevented as a result of the involvement of local authorities. A channel was made on the blocked mass, from which the dammed water began to flow. The river here restored its

initial water flow, and the next day, a channel was made on the second-dammed lake. As a result, the risk of flooding was eliminated. There was also no precipitation during this period.
